## Methane pollution at Slovakia's gas network and storage

Full results: [Clean Air Task Force: Field Report: Slovakia Monitoring Report 2026](#)

## Executive summary

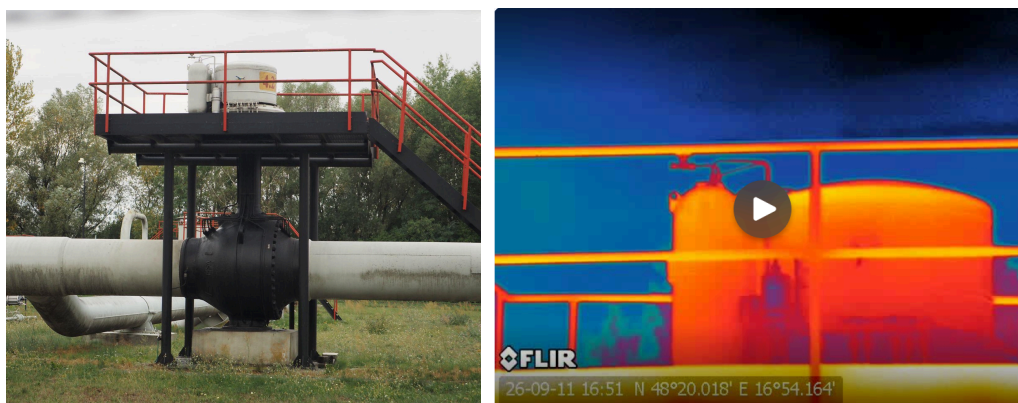
One particular type of gas-powered pneumatic device showed emissions at every location visited. The valve controller on high pressure segments of the gas pipeline (see below) was venting-by-design at five different locations.

Fig.1: Valve (venting-by-design) - Regulation station 1 Vysoká pri Morave [\[video link\]](#)

A large number of emissions could be avoided via better equipment standards, in particular the pneumatic devices emitting large plumes of methane on the midstream pipeline indicate that the zero venting-by-design equipment is yet to be implemented in the country.

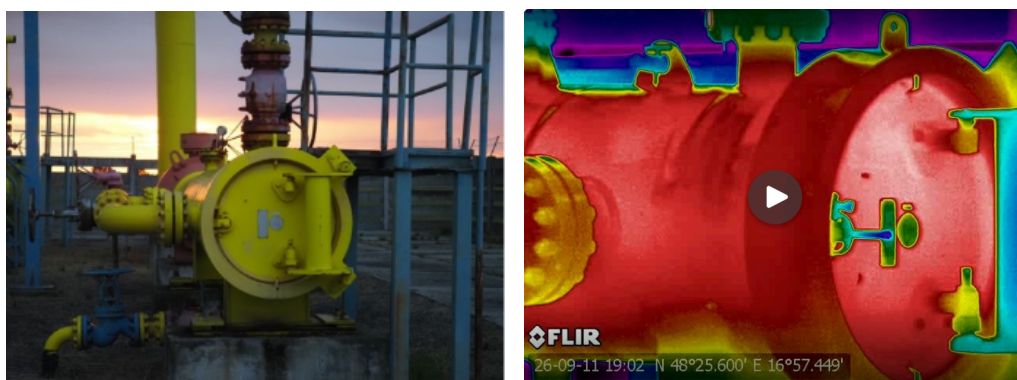
The team documented emissions from two poorly sealed scraper traps at this pipeline launcher and receiver station. The utilization of scrapers (“pigging”) is a routine practice used to clean and inspect pipelines by removing liquids and debris. Because each pigging operation requires depressurizing and opening the trap, gas can be released during these operations, and worn seals or improperly closed doors can cause continuous leaks like the one below.

Fig. 3: Pig trap - Čistiaci uzol plynovodov Jakubov [\[video link\]](#)
